**Flood Control Project Maintenance
Levee Inspections**

Fall 2014 Levee Maintenance Deficiency Summary Report

Sacramento River Basin

Sutter Maintenance Yard Maintenance Area 0013

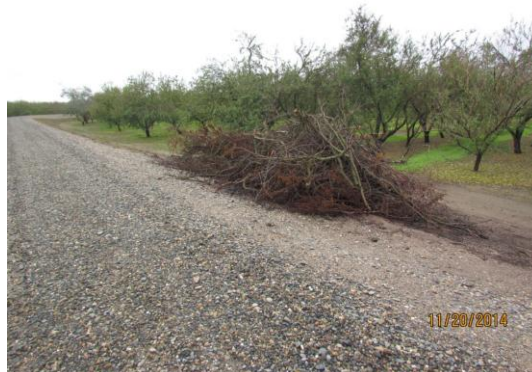
Photo 1 of 1 : FA_2014_MA0013_300_43_20141126_00012.jpg

LM Start	0.49	Rating **	M	Issue No.	43
LM End	0.49	Issue Type +	En	Location *	LS
Category	Earthen Levee			GPS Latitude/Longitude	
				Start	End
Item	Encroachments			39.591153 °	39.591153 °
				-121.701883 °	-121.701883 °
DWR ID	DWR_MA0013_01_f_2014_43				
Action/Comments					
Prunings

View of the prunings along the landside slope.

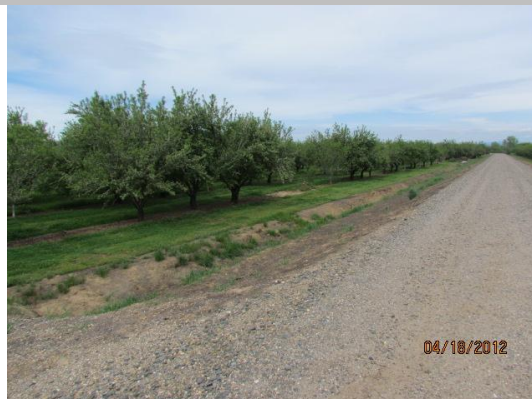
Photo 1 of 1 : FA_2014_MA0013_300_19_20141013_00010.jpg

LM Start	0.60	Rating **	M	Issue No.	19
LM End	0.60	Issue Type +	Ma	Location *	WS
Category	Earthen Levee			GPS Latitude/Longitude	
				Start	End
Item	Slope Stability			39.590173 °	39.590173 °
				-121.700617 °	-121.700617 °
DWR ID	DWR_MA0013_01_s_2013_19				
Action/Comments					
Repair the levee slope damaged by vehicle traffic and prevent access where possible.

View of the vehicle erosion along the waterside slope.

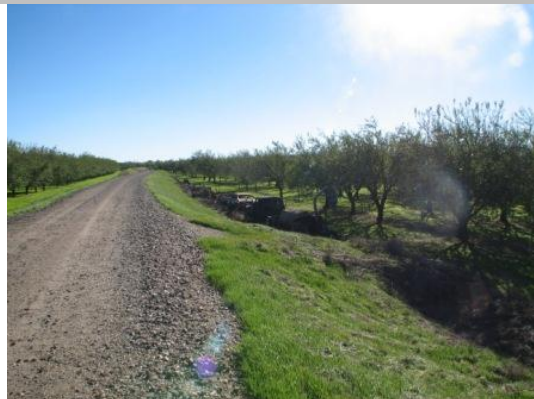
Photo 1 of 1 : FA_2014_MA0013_300_12_20141013_00006.jpg

LM Start	0.76	Rating **	M	Issue No.	12
LM End	0.78	Issue Type +	Ma	Location *	LS
Category	Earthen Levee			GPS Latitude/Longitude	
				Start	End
Item	Encroachments			39.587905 °	39.587505 °
				-121.700822 °	-121.700880 °
DWR ID	DWR_MA0013_01_s _ 2012_12				
Action/Comments					
Equipment

View of the equipment along the landside toe of the levee.

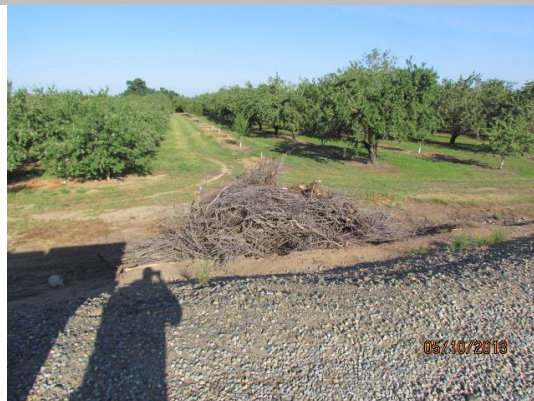
Photo 1 of 1 : FA_2014_MA0013_300_20_20141013_00011.jpg

LM Start	0.97	Rating **	M	Issue No.	20
LM End	0.97	Issue Type +	En	Location *	LS
Category	Earthen Levee			GPS Latitude/Longitude	
				Start	End
Item	Encroachments			39.584885 °	39.584885 °
				-121.700487 °	-121.700487 °
DWR ID	DWR_MA0013_01_s _ 2013_20				
Action/Comments					
Prunings

View of the prunings along the landside toe.

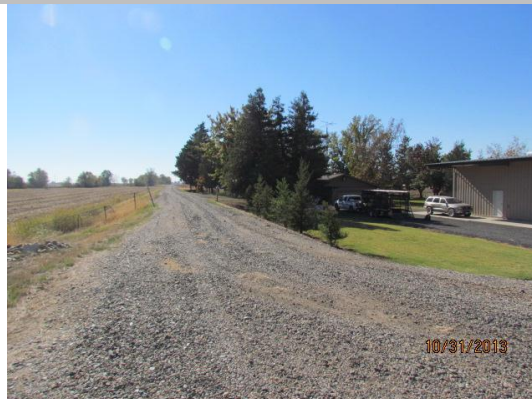
Photo 1 of 1 : FA_2014_MA0013_300_18_20141013_00009.jpg

LM Start	4.13	Rating **	M	Issue No.	18
LM End	4.20	Issue Type +	En	Location *	LS
Category	Earthen Levee			GPS Latitude/Longitude	
				Start	End
Item	Vegetation			39.541660 °	39.540651 °
				-121.707408 °	-121.707404 °
DWR ID	DWR_MA0013_01_s_2013_18				
Action/Comments					
Landscaping

View of the redwood trees along the landside slope.

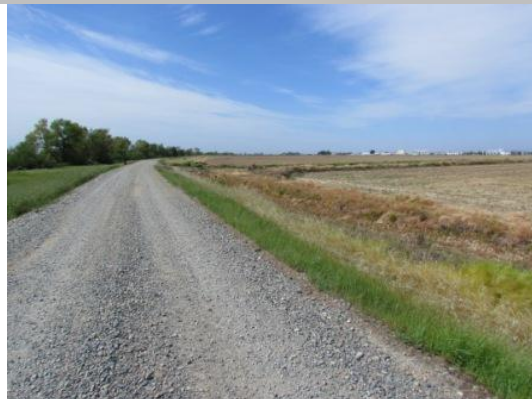
Photo 1 of 1 : FA_2014_MA0013_300_3_20141013_00002.jpg

LM Start	6.51	Rating **	M	Issue No.	3
LM End	7.09	Issue Type +	En	Location *	LS
Category	Earthen Levee			GPS Latitude/Longitude	
				Start	End
Item	Encroachments			39.508928 °	39.501438 °
				-121.714842 °	-121.719715 °
DWR ID	DWR_MA0013_01_s_2012_3				
Action/Comments					
Ditch

View of the agricultural ditch along the toe.

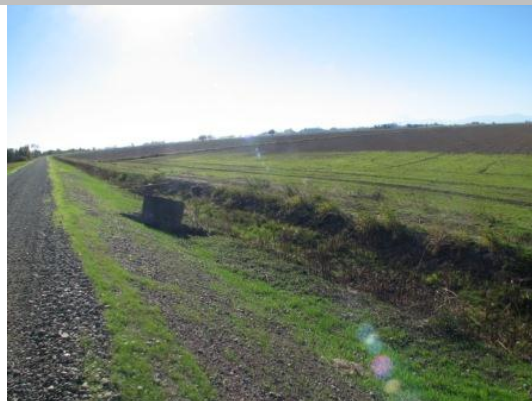
Photo 1 of 1 : FA_2014_MA0013_300_2_20141013_00001.jpg

LM Start	6.63	Rating **	M	Issue No.	2
LM End	6.63	Issue Type +	Ma	Location *	LS
Category	Earthen Levee			GPS Latitude/Longitude	
				Start	End
Item	Encroachments			39.507337 °	39.507337 °
				-121.715693 °	-121.715693 °
DWR ID	DWR_MA0013_01_s_2012_2				
Action/Comments					
Material

View of a concrete block along the toe.

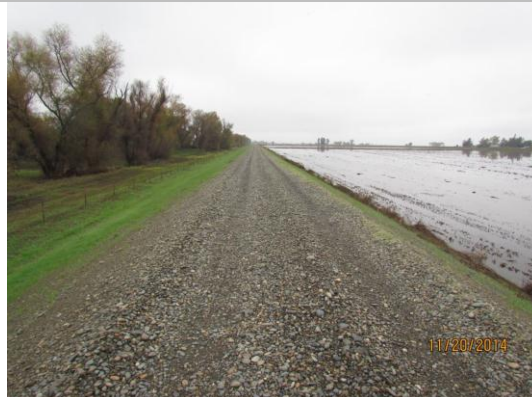
Photo 1 of 1 : FA_2014_MA0013_300_44_20141126_00013.jpg

LM Start	7.82	Rating **	A	Issue No.	44
LM End	7.82	Issue Type +	Ma	Location *	LS
Category	Earthen Levee			GPS Latitude/Longitude	
				Start	End
Item	Vegetation			39.492892 °	39.492892 °
				-121.727135 °	-121.727135 °
DWR ID	DWR_MA0013_01_f_2014_44				
Action/Comments					
Control annual grass and weeds on the levee slopes and easements.

View of the controlled vegetation on both slopes.

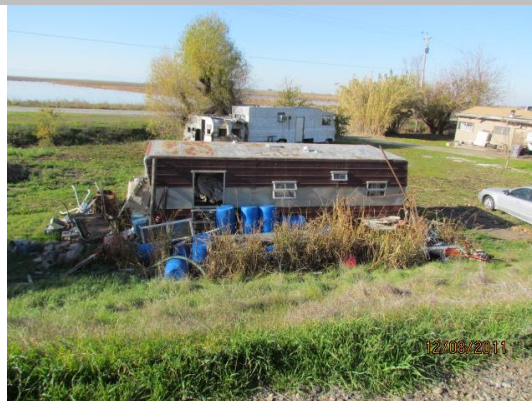
Photo 1 of 1 : FA_2014_MA0013_300_10_20141013_00005.jpg

View of a trailer & material along the L/S toe.

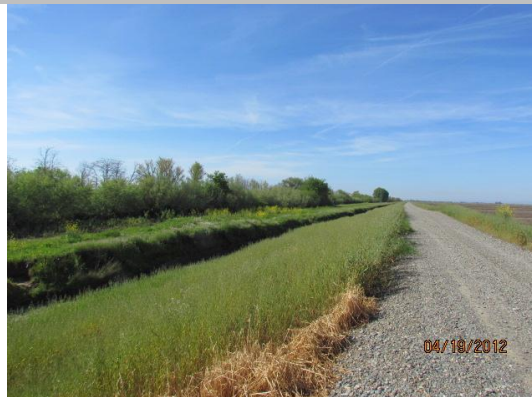
Photo 1 of 1 : FA_2014_MA0013_300_17_20141013_00008.jpg

View of the agricultural ditch along the toe of the levee.

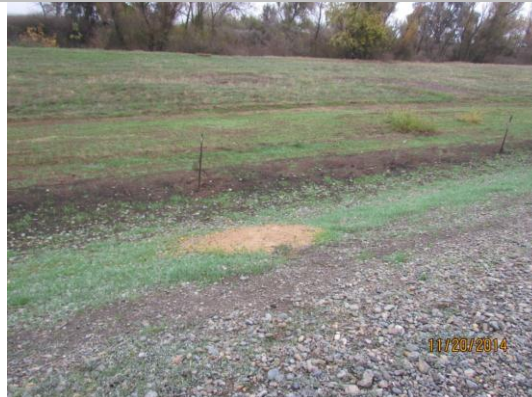
Photo 1 of 1 : FA_2014_MA0013_300_45_20141126_00014.jpg

LM Start	15.23	Rating **	A/W	Issue No.	45
LM End	15.23	Issue Type +	Ma	Location *	WS
Category	Earthen Levee			GPS Latitude/Longitude	
				Start	End
Item	Animal Control			39.405542 °	39.405542 °
				-121.800392 °	-121.800392 °
DWR ID	DWR_MA0013_01_f_2014_45				
Action/Comments					
No rodents visible, but rodent burrows visible; need to backfill and compact or grout burrows.

View of the rodent hole on the waterside slope.

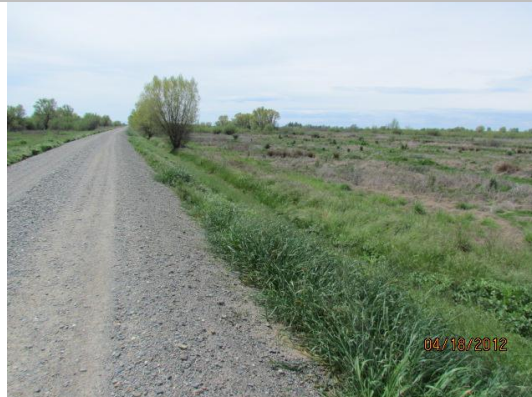
Photo 1 of 1 : FA_2014_MA0013_300_7_20141013_00004.jpg

LM Start	16.45	Rating **	M	Issue No.	7
LM End	17.42	Issue Type +	En	Location *	LS
Category	Earthen Levee			GPS Latitude/Longitude	
				Start	End
Item	Encroachments			39.394523 °	39.385580 °
				-121.817630 °	-121.831282 °
DWR ID	DWR_MA0013_01_s_2012_7				
Action/Comments					
Ditch

View of the ag along the toe of the levee.

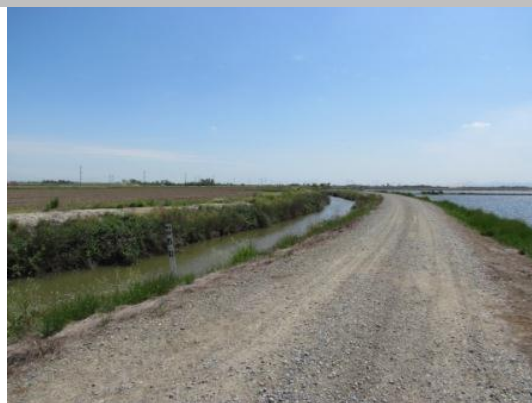
Photo 1 of 1 : FA_2014_MA0013_301_911_20141013_00015.jpg

Action/Comments					
Ditch

View of agricultural ditch along the toe.

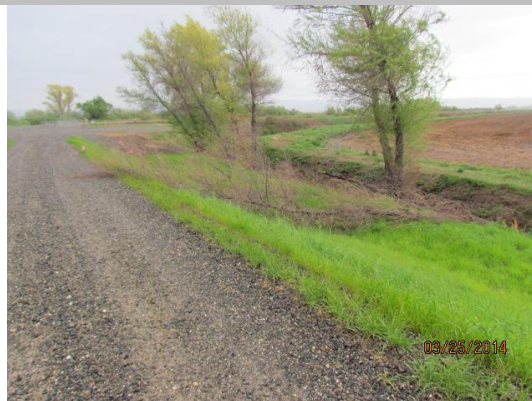
Photo 1 of 1 : FA_2014_MA0013_301_55_20141013_00013.jpg

LM Start	6.18	Rating **	M	Issue No.	55
LM End	6.18	Issue Type +	En	Location *	LS
Category	Earthen Levee			GPS Latitude/Longitude	
				Start	End
Item	Encroachments			39.521634 °	39.521634 °
				-121.706184 °	-121.706184 °
DWR ID	DWR_MA0013_02_s_2014_55				
Action/Comments					
Tree or limb

View of the tree limbs on the landside slope and toe.

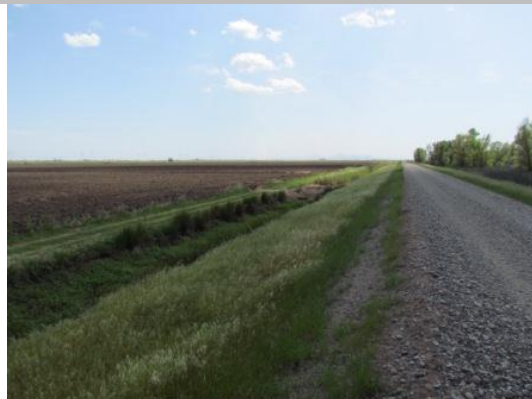
Photo 1 of 1 : FA_2014_MA0013_301_12_20141013_00005.jpg

LM Start	6.23	Rating **	M	Issue No.	12
LM End	7.62	Issue Type +	En	Location *	LS
Category	Earthen Levee			GPS Latitude/Longitude	
				Start	End
Item	Encroachments			39.520843 °	39.502958 °
				-121.706345 °	-121.716953 °
DWR ID	DWR_MA0013_02_s_2012_12				
Action/Comments					
Ditch

View of the agricultural ditch along the toe.

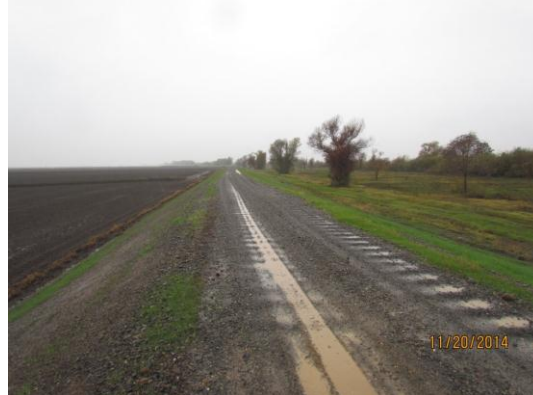
Photo 1 of 1 : FA_2014_MA0013_301_51_20141126_00016.jpg

View of the controlled vegetation on both slopes.

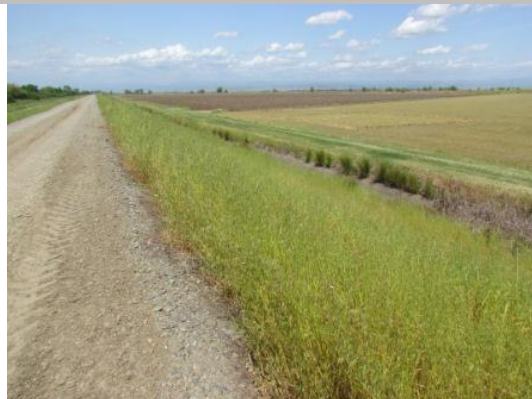
Photo 1 of 1 : FA_2014_MA0013_301_13_20141013_00006.jpg

View of the agricultural ditch along the toe.

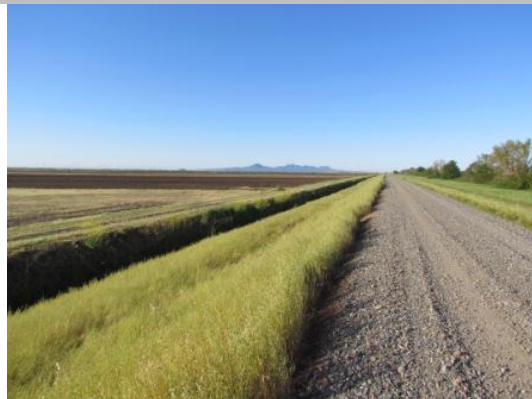
Photo 1 of 1 : FA_2014_MA0013_301_18_20141013_00007.jpg

View of the agricultural ditch along the toe.

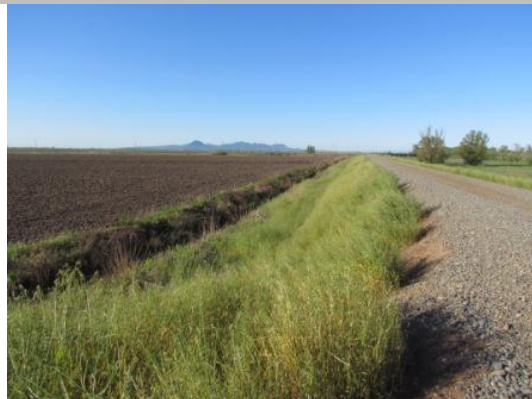
Photo 1 of 1 : FA_2014_MA0013_301_19_20141013_00008.jpg

View of the agricultural ditch along the toe.

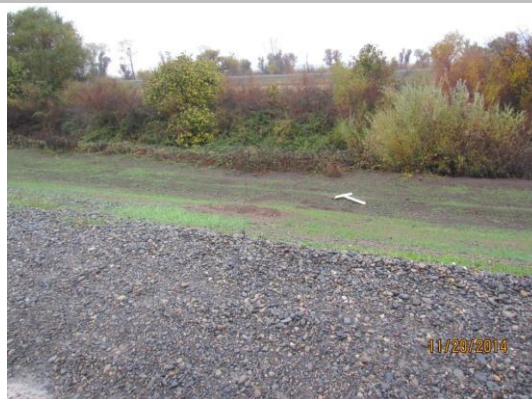
Photo 1 of 1 : FA_2014_MA0013_301_54_20141126_00017.jpg

LM Start	15.29	Rating **	A/W	Issue No.	54
LM End	15.29	Issue Type +	Ma	Location *	WS
Category	Earthen Levee			GPS Latitude/Longitude	
				Start	End
Item	Animal Control			39.409548 °	39.409548 °
				-121.789668 °	-121.789668 °
DWR ID	DWR_MA0013_02_f_2014_54				
Action/Comments					
No rodents visible, but rodent burrows visible; need to backfill and compact or grout burrows.

View of the rodent holes and bait station along the waterside slope.

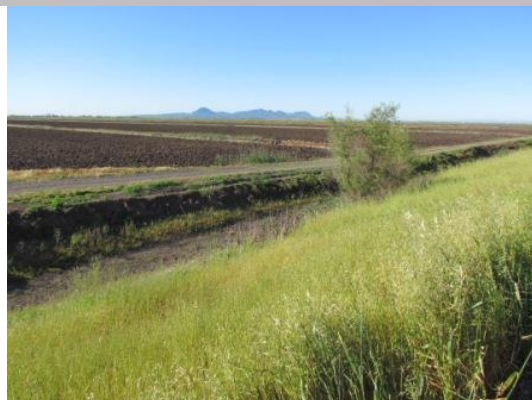
Photo 1 of 1 : FA_2014_MA0013_301_20_20141013_00009.jpg

View of the agricultural ditch along the toe.

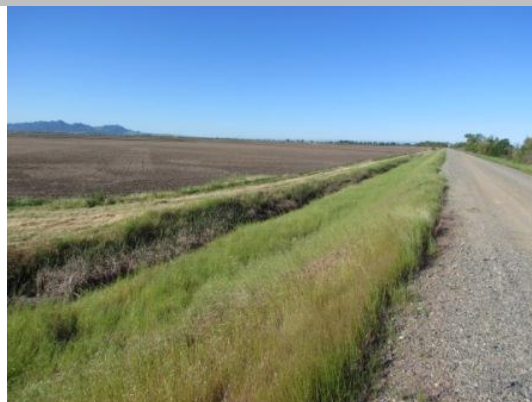
Photo 1 of 1 : FA_2014_MA0013_301_21_20141013_00010.jpg

View of the agricultural ditch along the toe.

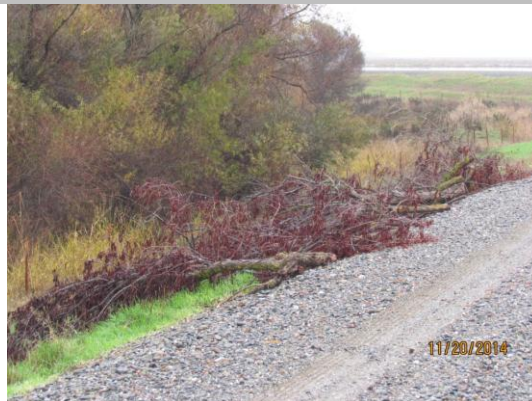
Photo 1 of 1 : FA_2014_MA0013_301_53_20141126_00018.jpg

View of the tree limbs along the waterside slope.

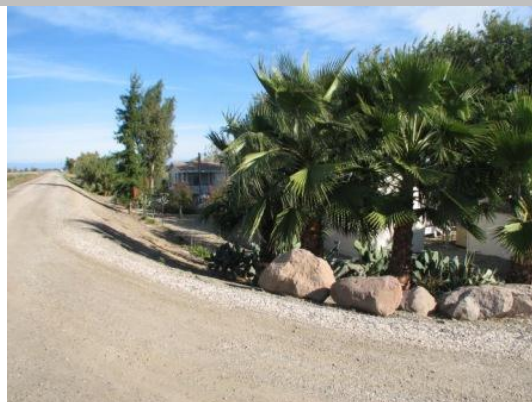
Photo 1 of 1 : FA_2014_MA0013_301_4_20141013_00001.jpg

View of landscaping along the toe.

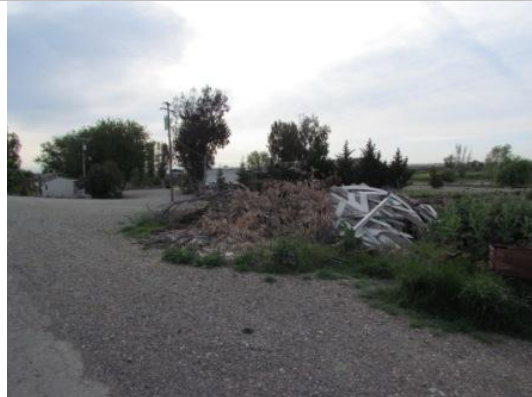
Photo 1 of 1 : FA_2014_MA0013_301_8_20141013_00004.jpg

View of the debris & prunings.

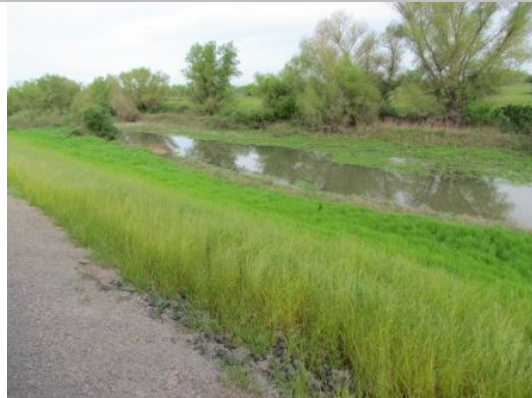
Photo 1 of 1 : FA_2014_MA0013_301_7_20141013_00003.jpg

View of the along the canal.
